# Light report

TEST PREVIEW - simulated findings; not an actual inspection.

## Sandpiper Gatehouse

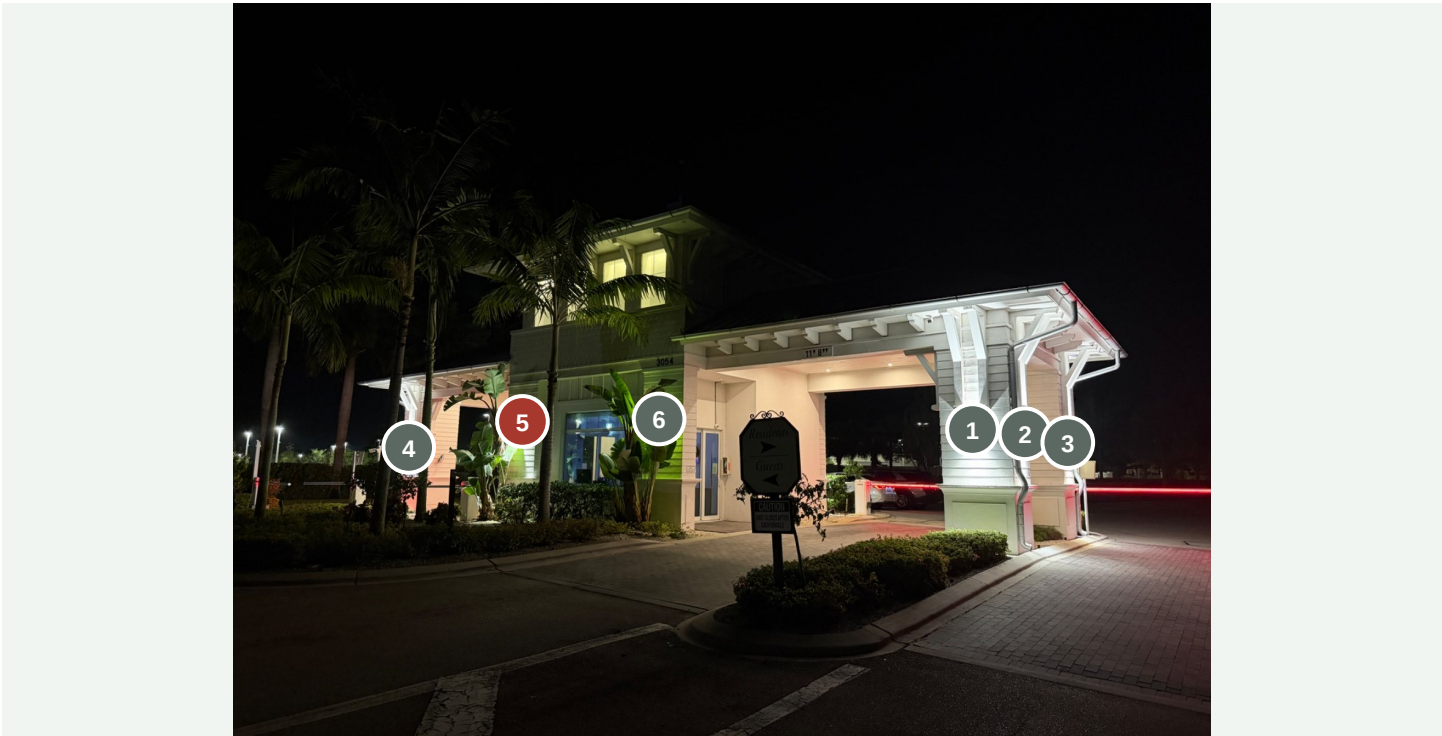
Reference photo: Sandpiper Gatehouse / Front

Front: Front Building Light 1 out.

Entry into Fiddler's Creek  
Front Building Light 1 out.

**Front Building Light 1**  
REPORTED OUT
